SERVICE BULLETIN

EFFECTIVE DATE: MAY 19, 1988 - Reprinted July 2014

**SUBJECT: ALL GAR-BRO LAYDOWN BUCKETS EQUIPPED WITH SWING TYPE
LIFTING BAIL FABRICATED FROM FLAT BAR AND PLATE**

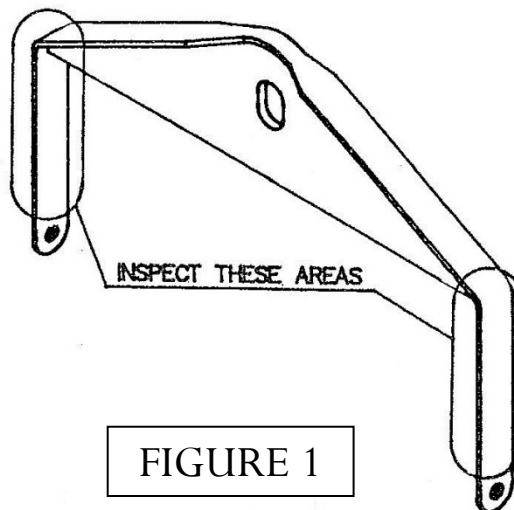
Investigation by the factory, additional stress analysis, and further metallurgical analysis by a qualified laboratory have indicated that these failures are due to fatigue cracks occurring close to the junction of the bail plate and the bail flat bar with subsequent failure occurring when these cracks are undetected during daily inspection and grow to the point of failure.

Visual examination of the failed lifting bails shows, in all cases, notches or indentations on the bail bar (see figure 1) in the area of the bail where the flat bar contacts the cone of the bucket when the bail is pivoted out of the way for charging of the bucket. As explained above, these notches will, over a period of time, cause a crack to form, and this crack will eventually grow to the point that insufficient flat bar is available to support the bucket when it is suspended, and the bail will fail. This process takes many, many lifting cycles to finally reach the point of failure, and our older buckets are reaching this point in their lifetime.

Visually inspect the lifting bail in the general area where the flat bar intersects the steel plate beam for cracks, dents, or nicks as indicated on (Figure 1). The inspected area includes both the outer edges of the flat bar (narrow dimension) and the width of the bar (large dimension). Inspection should be made using sound visual inspection techniques aided by dye penetrant inspection. These inspection requirements should be accomplished on each bail as a minimum standard, with further testing using ultrasound or other inspection methods if personnel are so trained.

In the event that a crack, cracks, or nicks are found, the bail **MUST BE REMOVED FROM SERVICE AND DESTROYED. DO NOT ATTEMPT TO REWELD OR REPAIR IN ANY WAY ANY CRACKS OR NICKS.** Repair of the nicks or cracks by grinding out the material and re-welding must not be attempted since this does not really remove the problem because the weld material added is harder and, therefore, more brittle than the parent bail material and thus has even less tolerance to fatigue cracking than the original bail.

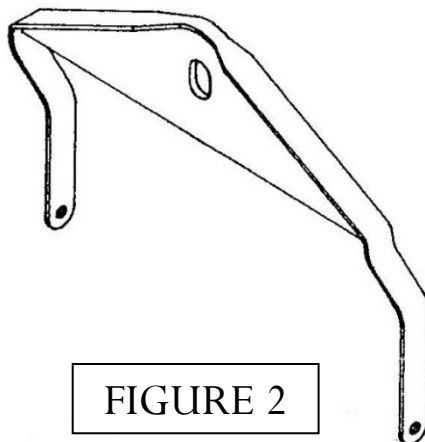
Inspect the bail flat bars as shown in (Figure 2, next page) for distortion due to excessive side loading when the bucket was hoisted. Note that the distortion shown in the drawing is greatly exaggerated and any bending in the bail flat bars will probably be much less than shown. Any deformation, regardless of magnitude, as shown in the figure requires that the bail be **REMOVED FROM SERVICE AND DESTROYED.** Straightening of the bail flat bars while cold or by heating and rebending should not be attempted because of the possibility of hardening the flat bar and reducing its tolerance to metal fatigue (See Figure 2, next page).
